**Project:** Optimizing tori line designs for pelagic tuna longline fisheries

Report of work under New Zealand Ministry of Fisheries Special Permit 355

August 5, 2008

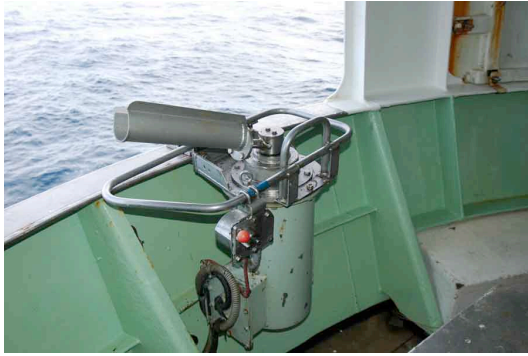
Figure 1. Bait casting machine.

The observed vessel was over 55 m (length overall) with a crew of 22 persons. It sets longlines at a vessel speed of 10.6 knots and retrieves gear on average at 6.6 knots. Baited hooks were deployed using a bait casting machine (Figure 1), which delivered each bait approximately 8 m to the port side beyond the vessel's wake every 7 seconds. The bait casting machine functions to uncoil the monofilament trace of the branchline without tangles, thus making the setting process more efficient and consistent. Floats are tossed just starboard of the midline or at the midline.

Clearly the seabird bycatch mitigation tools – dual tori lines and 12 g leads on each hook – failed during daylight hours, killing 20 birds in 138 minutes. This failure was due to the bait casting machine delivering baited hooks 2-3 m outside the port tori line and the first streamer of the tori line being over 25 m astern<sup>3</sup>. Together these factors left a 20 m span that seabirds could exploit baited hooks at will. When the first streamer of the port tori line was moved to within 11 m of the stern on the second day, the capture rate dropped from 0.30 birds per min to 0.08 birds per min. Although an improvement, this rate of seabird mortality is unacceptable. Being that baits landed port of the port tori line, the starboard tori line became irrelevant to scaring birds. In this case, the bait casting machine neutralized the mitigation effect of tori lines by pitching the bait beyond their protection. Bait loss to birds of 14.7% to 15.9% could have huge negative consequences for the fishing operation – a clear example of a no-win situation.

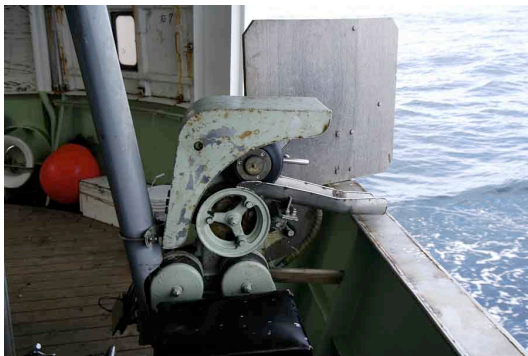
Figure 2. Lineshooter.

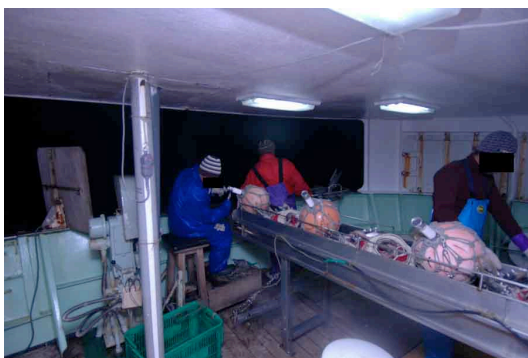
Figure 3. Setting longlines.

floats and branchlines ready for deployment (Figure 3). A third crewman baited the hooks on coiled branchlines stacked in piles of ten between tuna floats. In each basket of ten branchlines, three hooks were baited with whole *Illex* squid and the other seven were baited with whole sardine. The sequencing of the two bait types was consistent from basket to basket and set to set. Twenty “baskets” were deployed between radio beacons. Fourteen units of 20 baskets were deployed each set for a total of 2,840 hooks over an estimated distance of just less than 60 nm. This process takes 5.5 hours. Sets were made from north to south while hauls retrieved gear from south to north (See Anderson and McArdle 2002, Figure 1, for basic description of pelagic longline gear).

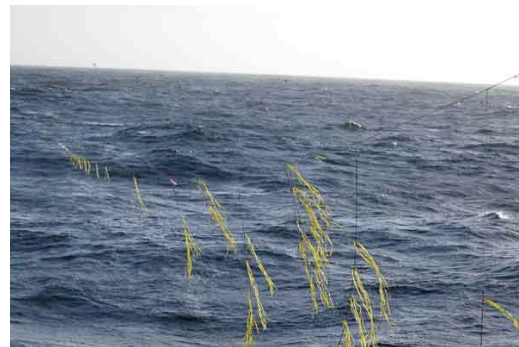
Figure 6. Tori lines.

The Vessel deployed two, 200 m long tori lines (Figures 5 and 6): one from a tori pole on the port side (Figures 7 and 8) and one from a mast centered at the stern. Individual streamers were made of polypropylene line approximately 10 mm in diameter with three strands of yellow plastic packing strap material folded through the twist in the poly line such that one meter of strapping extended from either side (Figure 9). Individual streamers were attached to swivels in the backbone with tuna snaps. Streamers extended to the water in light wind. Six streamers were attached to the tori line as the gear was deployed. The distance between the first streamer and the stern was approximately 25 m, but was reduced to within 11 m after the sixth day of fishing<sup>2</sup>. Single strands of yellow packing material were fitted through the twist of the poly backbone (sometime referred to as the bottlebrush style; Figure 6) beyond the last streamer.

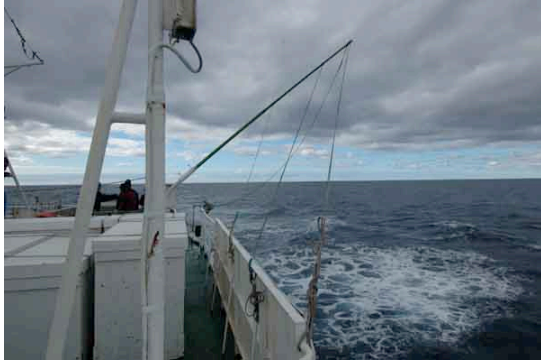
Figure 7. Port tori pole

The port tori pole stood approximately 13 m above the water. Its base was a stout, 2 m davit that arced 30 degree outboard from vertical at its top (Figure 8). The remainder of the pole was round stock steel telescoping in decreasing diameter and was further secured with 3 backstays running to the forward port rail. The tori pole (Figure 7) extended the

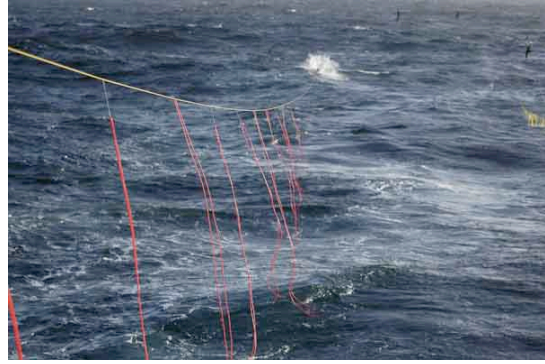
Figure 10. Alaskan tori line.

A tori line of the Alaskan design (Melvin 2000) was deployed on 29 April from the stern mast or starboard tori line with a road cone minus the rectangular base (see results) as a towed device (Figures 10 and 11).

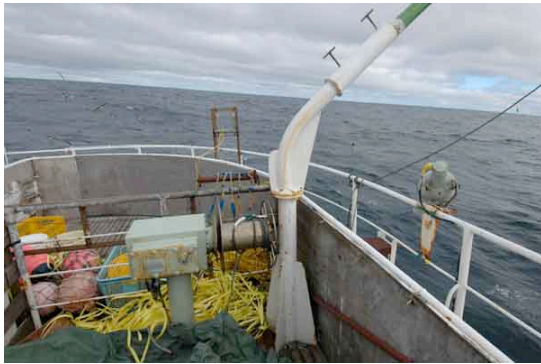
Figure 6. Port tori pole davit and winch.

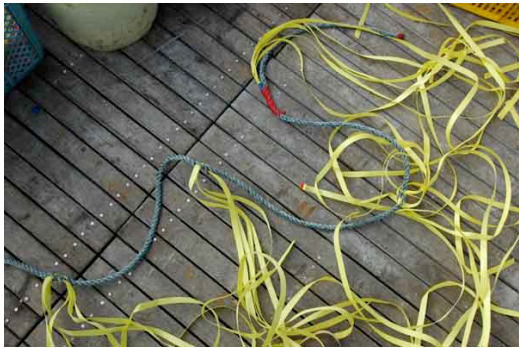
Figure 9. Joint venture vessel tori line streamers.

Although tori line designs could not be compared quantitatively, the multiple packaging straps passed through the twist of the line making up the streamers and the line making up the backbone as used on this vessel could make these lines look bigger especially if the color were changed to red or orange. It is extremely difficult to imagine that a tori line with only packing straps passed through the backbone and devoid of streamers could be effective at scaring birds. We were poised to compare the performance of tori lines with and without streamers; however, the extreme seabird mortality seen during daylight hours preempted that comparison.

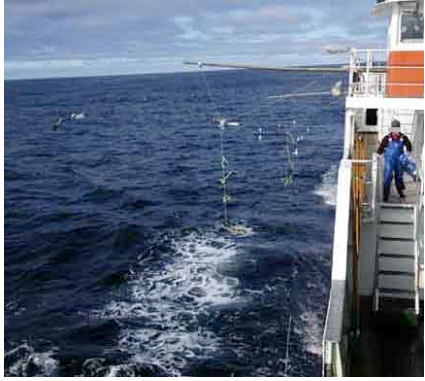
Figure 12. Haul mitigation.

The observed vessel also used mitigation to prevent seabird bycatch while hauling longlines (Figures 12 and 13). Haul mitigation consisted of two 3 to 4 m stout bamboo booms lashed to the forward and aft stairway railings at the top deck with single poly line suspended from it. The suspended line had yellow packing strap material pushed through the twist of the line at approximately one meter intervals and held a plastic ring with bands of packing strap material hanging from the ring that just touched the water. This haul mitigation system was very effective at keeping birds away from baited hooks as gear was hauled – no interactions with hauled baited hooks were observed as retained bait was discarded at or near the starboard sea door.

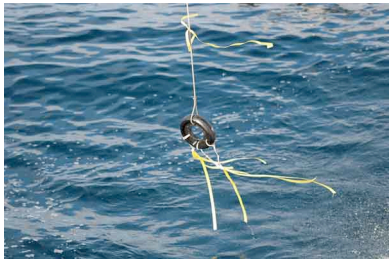
Figure 13. Close up - haul mitigation.

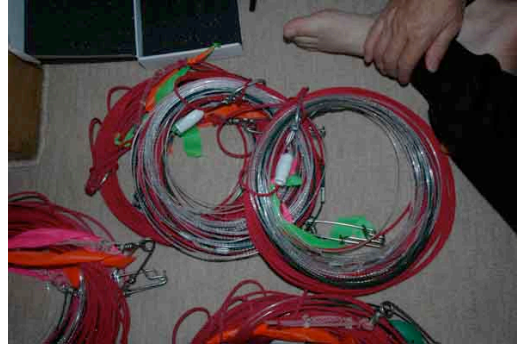
Figure 14. Star-Oddi TDRs taped to branchlines at the hook.

Star–Oddi time depth recorders (TDRs), model DST Centi – ex, were used to measure the sink rate of baited hooks (Figure 14). These devices are relatively small and light measuring 15 mm x 46 mm and weighing 12g in water and 19g in air. These instruments were configured by the manufacturer to measure depth at 0.07 m intervals with an accuracy of  $\pm 0.12$  m every second from 1 m to 280 m. TDR data files were converted into EXCEL worksheets and transducer records were adjusted to the transducer reading at the known depth at 2 m as determined from static tests for each instrument. Time in seconds and sink rate in m/sec were calculated for each TDR record to 2 m, 5 m, and 10 m depths. In addition, the fishing depth and temperature one hour post setting were tabulated with the hope that it might provide some insight to the fishing operations.

On 25 April a single TDR was deployed. It was placed 1 m above the hook attached with Tesa tape and white plastic tape favored by the Fishing Master. With successful retrieval of this one TDR, two multiple TDR deployments were made on 26 and 27 April. In the first, five TDRs were attached with white plastic tape just above the weight at the hook on the first, third, fifth, seventh, and ninth branchlines within a single ten branchline basket. In the second, TDRs were attached in the same way to the 5<sup>th</sup> branchline in the first two baskets of the first, fourth, seventh, tenth and 13<sup>th</sup> 20 basket units between radar reflectors

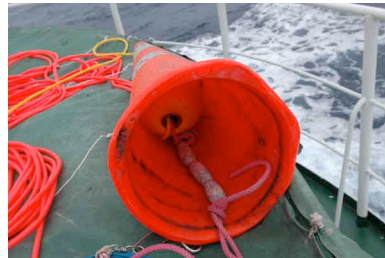
Figure 15. Modified road cone with 1.7 kg weight as a tori line towed device.

A 1-m road cone was deployed on a 6.4 mm diameter line to determine how it would track and function as a tori line towed device. In this case the goal was to increase drag so as to increase the aerial extent and to have the device track in a predictable manner. The cone held in the water but would release suddenly flying up to a meter in the air leaving the 50-line to go alternately slack and very tight. This erratic behavior was deemed too unpredictable to function as a towed device for a tori line on a vessel setting at over 10 knots. At the suggestion of the Fishing Master, the rectangular base of the cone was removed leaving a simple cone shape with less drag (Figure 15). This altered cone was deemed acceptable because the cone tracked predictably holding the line at constant tension. The cone was rigged to the Alaska style tori line, which was deployed from the aft mast on the set made on 29 April.

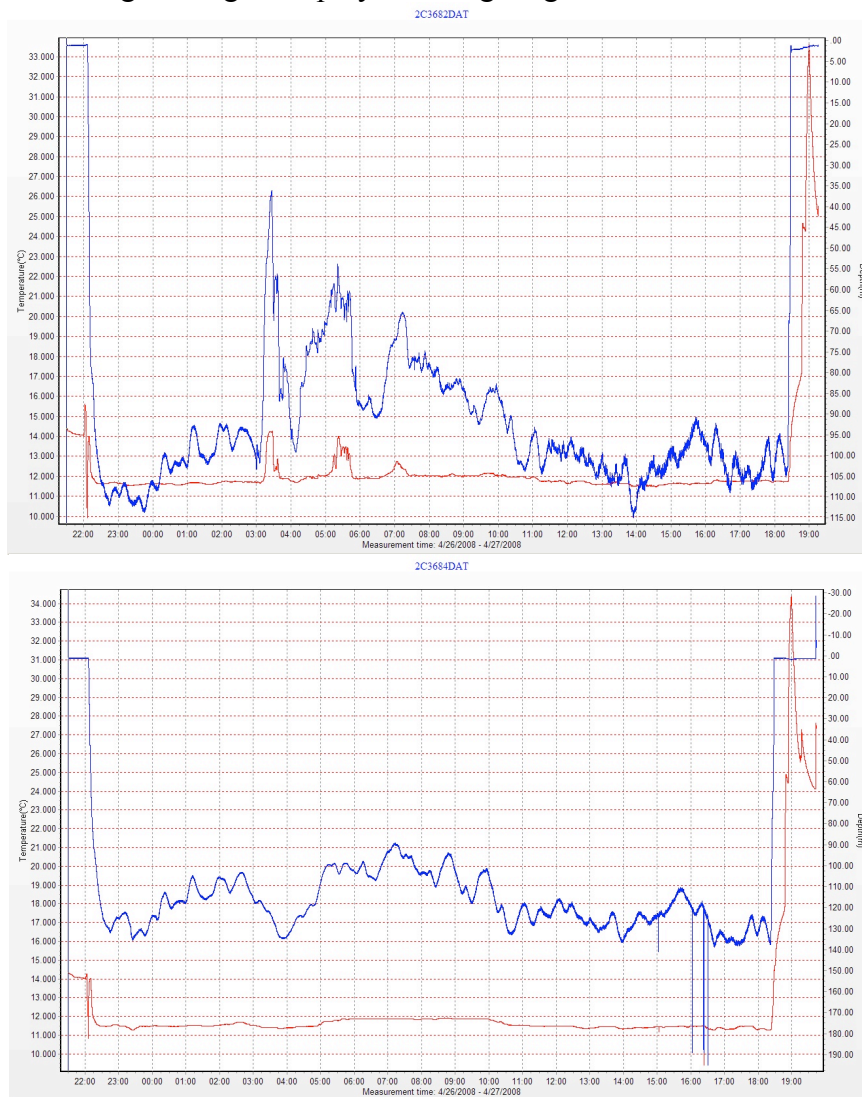
Figure 16. The depth (m) and temperature (°C) for TDRs 3 (top) and 5 (bottom) deployed 26 April 2008 throughout a gear deployment targeting southern bluefin tuna.

In the within basket comparison, the hook on branchline one (closest to the float) reached 62 m, while, the hook on branchline 7 reached 127.4 m (Table 2). Temperature varied little for hooks 3 to 9 (11.5° to 11.6° C) beyond 100 m, while the shallower branchline at 62 m occupied water over 2 degree Celsius warmer (13.9°). Branchline 3 occupied a wide range of depths (35 m to 115 m) throughout the set suggesting a fish capture (Figure 16, top). Hook five occupied a narrower range of depths (< 90 m to 135 m) and a fairly constant temperature (Figure 16, bottom). All 15 records with the TDR at the hook showed a continuous sine wave throughout the set perhaps suggesting the catenary of line between floats and the branchlines are in a state of constant up-down motion.
